Manhole Inspection Summary

Manhole # **S15A__010MH**

Location Address: **INTER- RAYNOR**

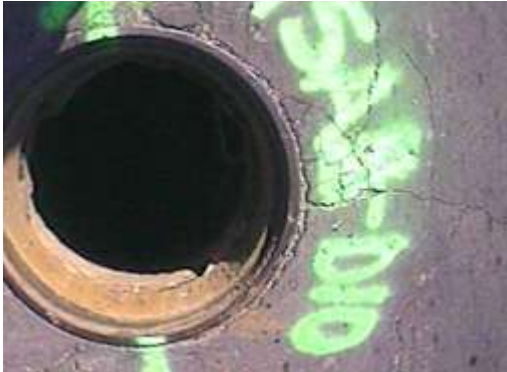
Top View

Offset: **1** (in.)

FRAME OFFSET

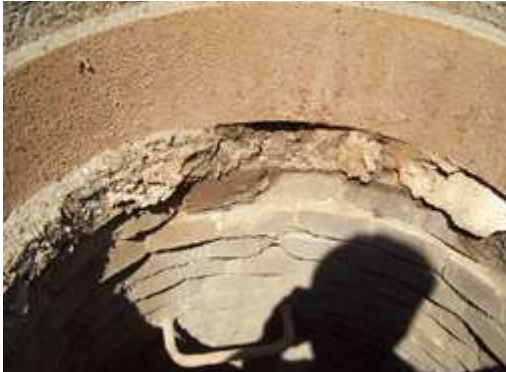
Defect 1

Condition: ☐ Sound ☒ **Cracked** ☐ Root Intrusion ☐ Loose Brick ☒ **Deteriorated**

DETERIORATED AND CRACKED
CHIMNEY

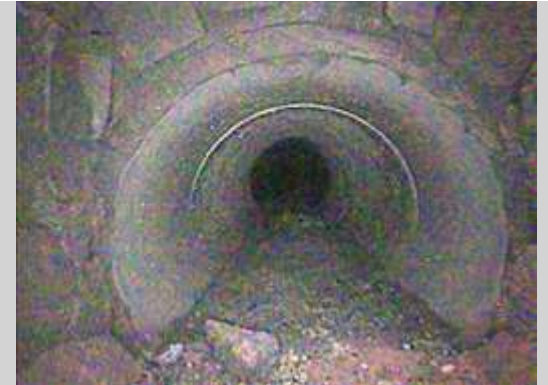
12 O'Clock Outflow

10 in. Circular Gravity Sewer
Pipe Out @ 12 O'Clock

Deposits: ☐ None ☐ Mud ☐ Sludge ☒ **Debris** ☐ Grease

Silt Depth: **2** (in.) Deposits Extent: **Medium**

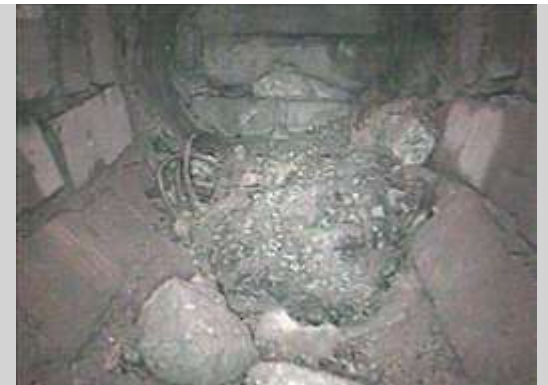
6 O'Clock Inflow

8 in. Circular Gravity Sewer
Pipe In @ 6 O'Clock

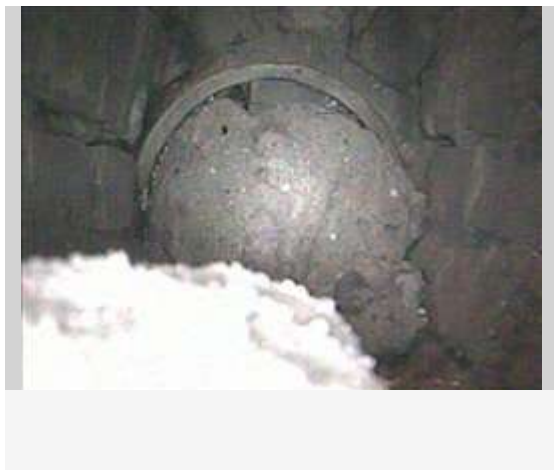
Pipe In @ 9 O'Clock

10 in. Circular Gravity Sewer

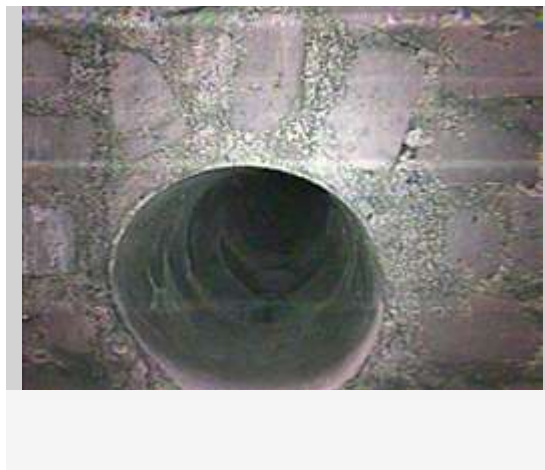
Drop In @ 9 O'Clock

Drop: **Outside Direct**

Drop Condition: **Open**

Connects To: **Stub connection / abandoned**
